# School Assessment Report

District: Canon City RE-1  
School: Madison Exploratory  
Date: Mar 31, 2011

### School Name: Madison Exploratory

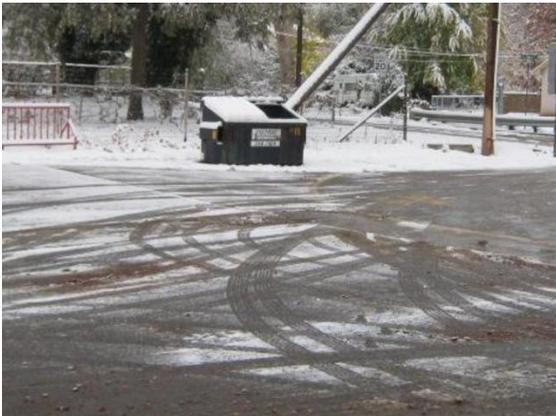
**System:** G2040 - Site Development

**Analysis:** The system is missing.

**Distress:** Missing

**Recommendation:** The system should be installed.

**Correction:** Replace and/or add fencing for security/appearance

**Condition Budget:** \$6,331

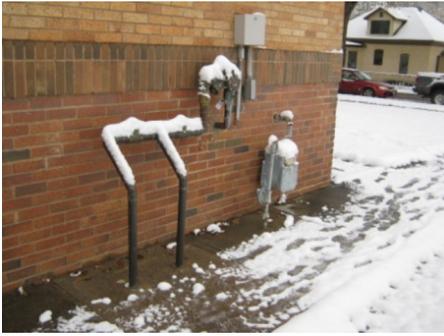
Location: Site  
Material: Site Development  
Distress: Missing  
Category: Capital Renewal  
Priority: 3 - Necessary- 2-5 Yrs  
Notes: The gas meter is not fenced.  
Correction: Replace and/or add fencing for security/appearance  
Qty: 25-L.F.  
Condition Budget: \$2,638

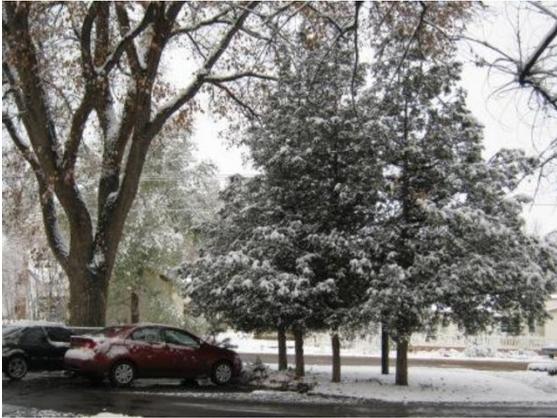
**System:** G2050 - Landscaping

**Analysis:** The system age is either beyond expected life or does not meet its intended performance under the Guidelines. The system may be in service and functioning but it is recommended to be replaced due to probable increased condition budget needs, the potential failure of its components, or in order to meet the performance Guidelines for this system. The system was installed in 1996. It has a 10-year service life which expired in 2006.

Location: Site  
Distress: Beyond Expected Life  
Category: Deferred Maintenance  
Priority: 3 - Necessary- 2-5 Yrs  
Correction: Renew System  
Qty: 1-Ea.  
Condition Budget: \$31,701

**Recommendation:** The system should be replaced.

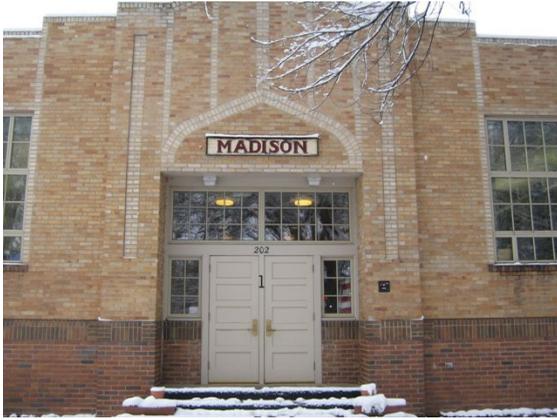
Analysis: The system is in use and functioning with an estimated remaining service life as indicated in the report section "Condition/Replacement Budget Detail". The system was installed in 1996. It has a 30-year service life. However, in the assessment, it was found to be currently deficient.

Location: Main  
Material: Exterior Doors  
Distress: Beyond Expected Life  
Category: Deferred Maintenance  
Priority: 3 - Necessary- 2-5 Yrs  
Notes: Replace exterior doors as needed. Client reported, "The exterior doors all have different installation dates. The front entrance is the original from 1924, the back entrance was replaced in 2008, and the side entrance was installed in 1996."

Recommendation: The system should be replaced.

Correction: Replace Solid Core Wood Doors  
Qty: 2-Ea.  
Condition Budget: \$8,898

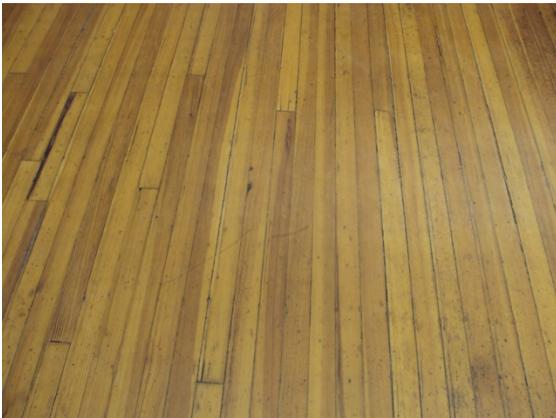
System: C3020 - Floor Finishes

Analysis: The system age is either beyond expected life or does not meet its intended performance under the Guidelines. The system may be in service and functioning but it is recommended to be replaced due to probable increased condition budget needs, the potential failure of its components, or in order to meet the performance Guidelines for this system. The system was installed in 1924. It has a 20-year service life which expired in 1944.

Condition Budget: \$97,466

Recommendation: The system should be replaced.

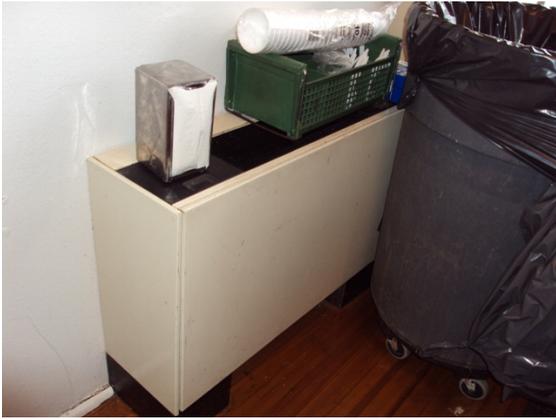
System: D3050 - Terminal & Package Units

Analysis: The system age is either beyond expected life or does not meet its intended performance under the Guidelines. The system may be in service and functioning but it is recommended to be replaced due to probable increased condition budget needs, the potential failure of its components, or in order to meet the performance Guidelines for this system. The system was installed in 1996. It has a 15-year service life. However, in the assessment, it was found to be currently deficient.

Recommendation: The system should be replaced.

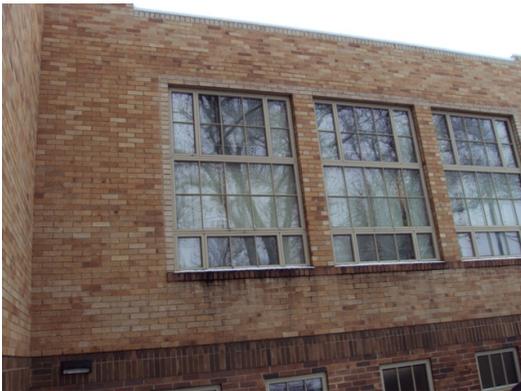
System: D5020 - Lighting and Branch Wiring

Analysis: The system is missing.  
Recommendation: The system should be installed.

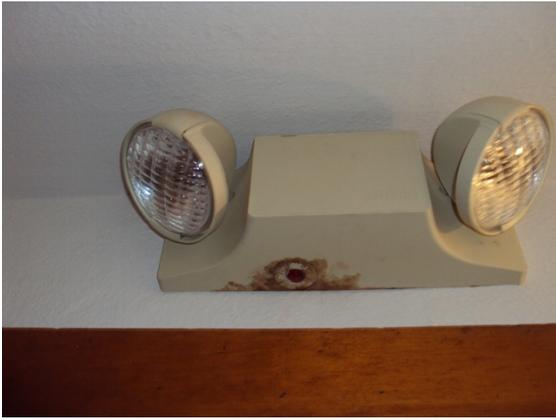
System: D5090 - Other Electrical Systems

Analysis: The system age is either beyond expected life or does not meet its intended performance under the Guidelines. The system may be in service and functioning but it is recommended to be replaced due to probable increased condition budget needs, the potential failure of its components, or in order to meet the performance Guidelines for this system. The system was installed in 1996. It has a 15-year service life. However, in the assessment, it was found to be currently deficient.
