School Assessment Report

District: Canon City RE-1

School: Harrison K-8

Date: Mar 31, 2011

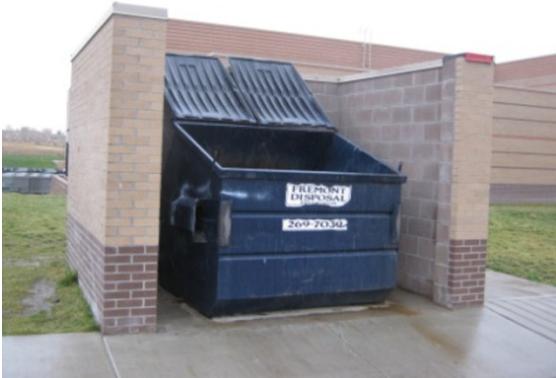
System: G2040 - Site Development

Analysis: The system is missing.

Distress: Missing

Recommendation: The system should be installed.

Correction: Replace and/or add fencing for security/appearance

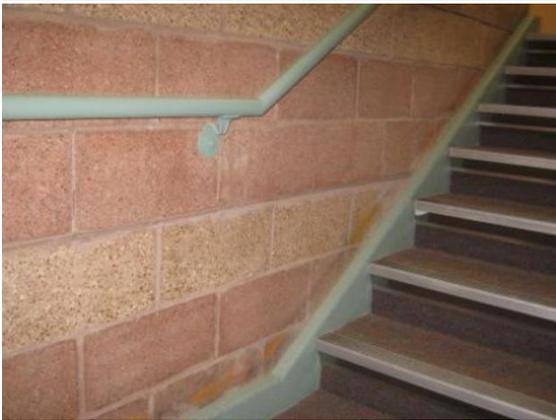
System: B2010 - Exterior Walls

Analysis: The system is in use and functioning with an estimated remaining service life as indicated in the report section "Condition/Replacement Budget Detail". The system was installed in 2006. It has a 100-year service life. However, in the assessment, it was found to be currently deficient and is non-renewable.

Distress: Failing

Notes: Some cracks have appeared in the CMU walls on the East side of the building indicating that settlement has occurred. A study should be done to determine the extent of structural damage.

Recommendation: The system should be replaced.
